Intel® Itanium™ Processor

Specification Update

June 2001

Document Number: 249720-001

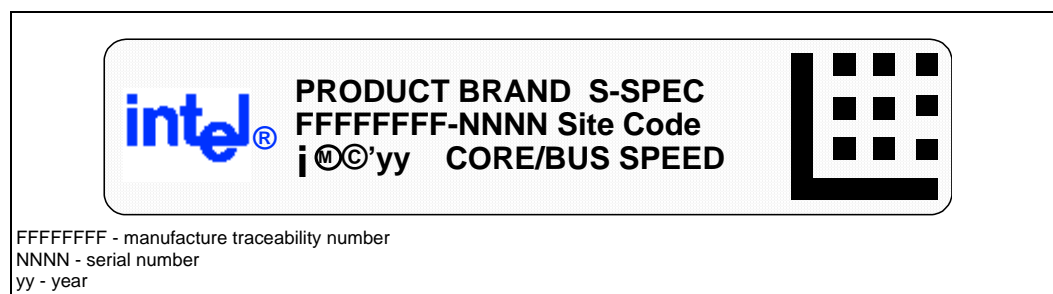
The cartridge mark for the product is a laser marked label attached to the end of the PAC418 cartridge opposite the power tab. The mark provides the following information:

- Product brand name
- Manufacture traceability (including manufacturing lot and unit identification)
- Manufacturing site
- Mask work and copyright protection for the processor and cache die
- Product identification (including processor core speed, cache size, bus speed)
- Intel company logo
- Two-dimensional product identification matrix for Intel internal use
